### **Paint Analysis at York Assembly Rooms**

**Client: York Conservation Trust**

**Report Author: Paul Croft**

**Date: October 2017**

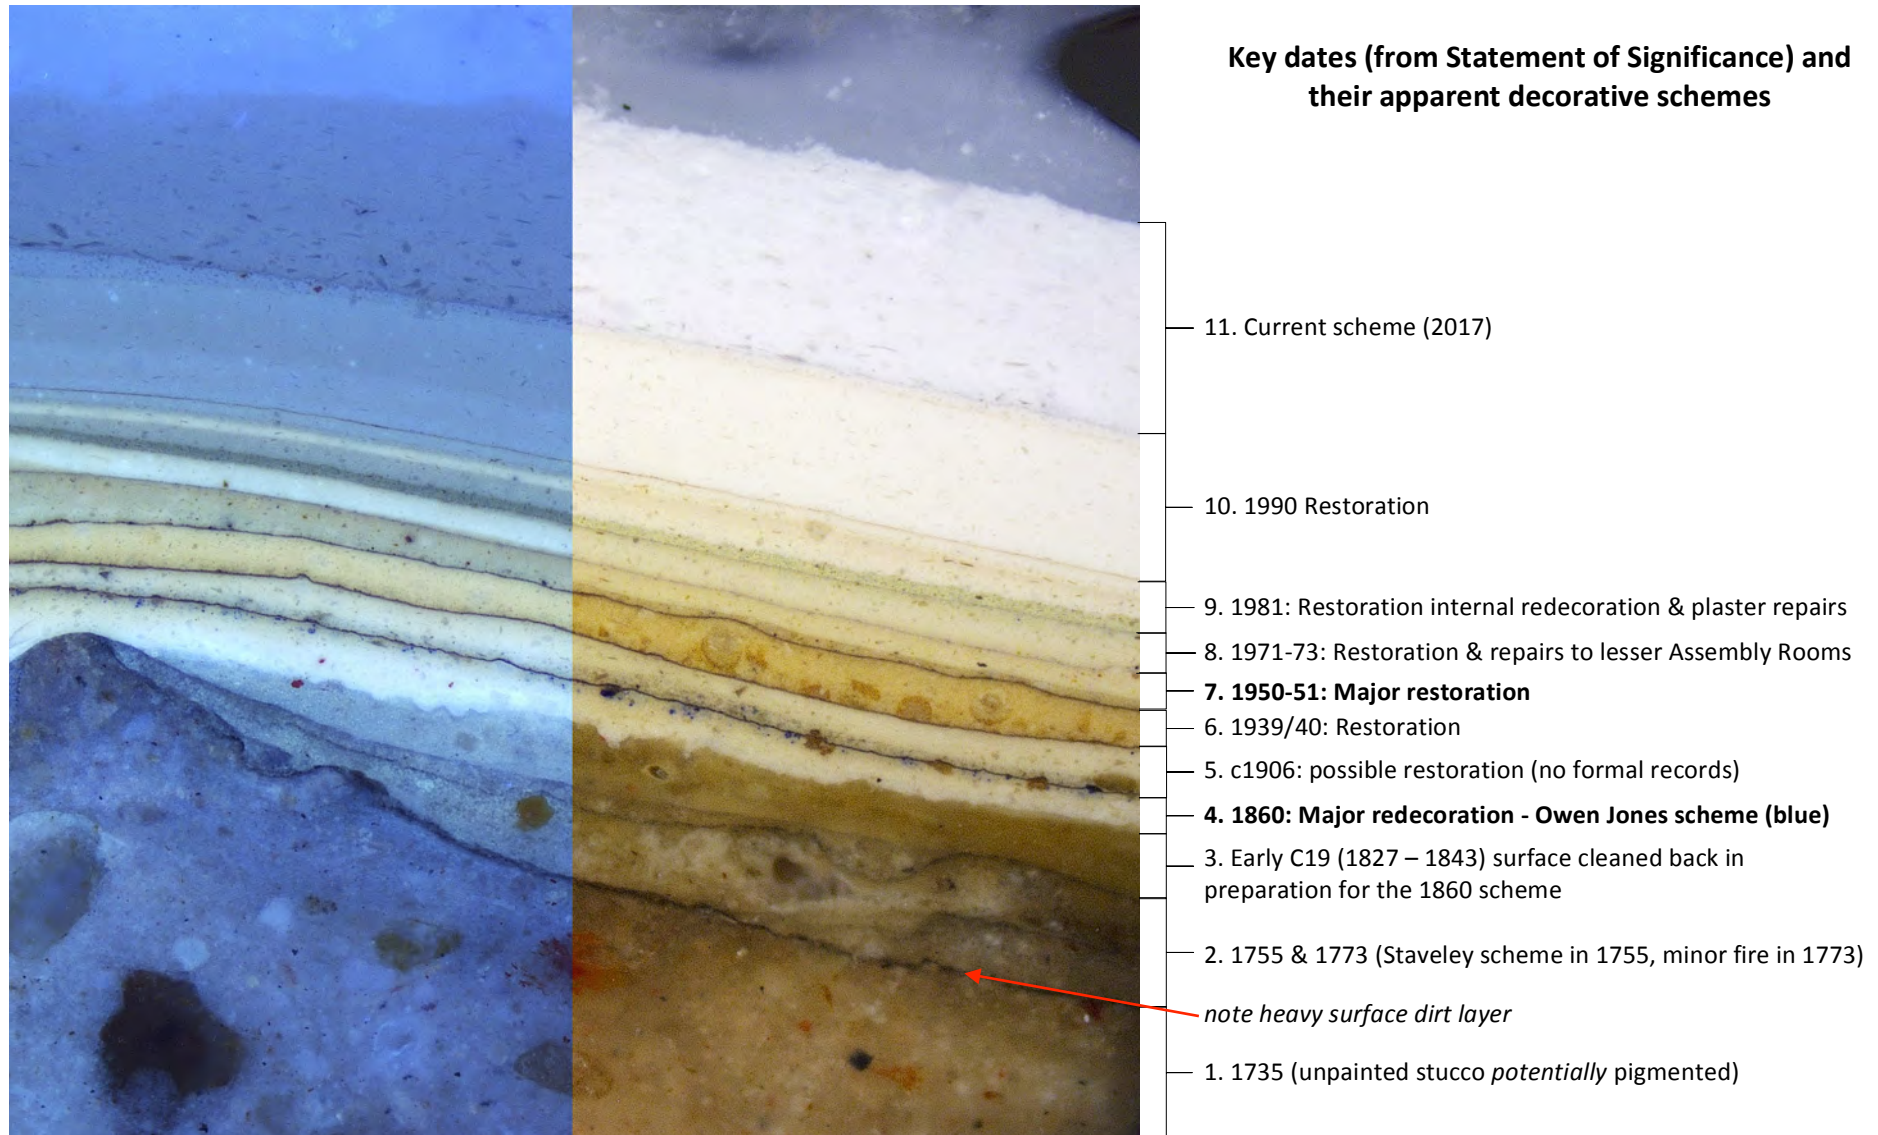
Fig.3: Sample 1.3, modillions stucco cornice

Fig.3 displays a photomicrograph of a key sample removed from the modillion on the stucco cornice. The plaster substrate is at the base with a distinctive heavy dirt layer on the surface indicating the cornice was originally left unpainted. This dirt layer is consistent across all samples removed from the cornice and are probably sooty deposits as a result of burning tallow candles in the early C18 to light the space.

In addition, the surface layer of the stucco contains fine grains of sand along with traces of what appears to be pigment. This is very unusual and certainly warrants further investigation and research.

An examination of other samples removed from the cornice appear to include a range of earth pigments (e.g. ochre and umber) in the surface layer of the stucco, suggesting a deliberate attempt to present the interior in subtle shades of stone colour possibly to further accentuate the impression of a stone interior.

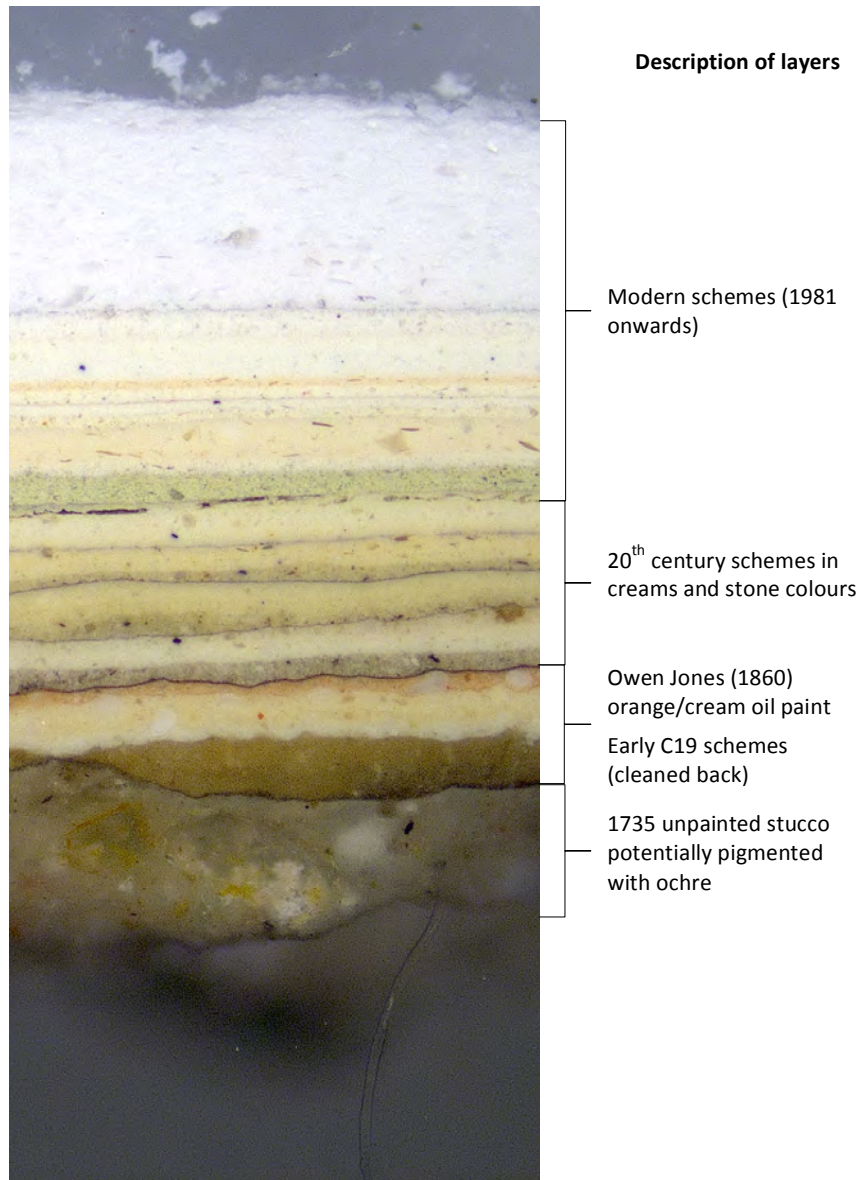
**Fig.4: Sample 1.2 (frieze beneath modillions)**

This was the first time colour was introduced to the interior with evidence for blue, orange, creams and some gilding to the cornice

(see figs 4 & 5). The Owen Jones decorative schemes appears to have been retained until the early 20<sup>th</sup> century when a theme of predominantly cream oil paints were introduced until the 1990 and current 2017 schemes in white.

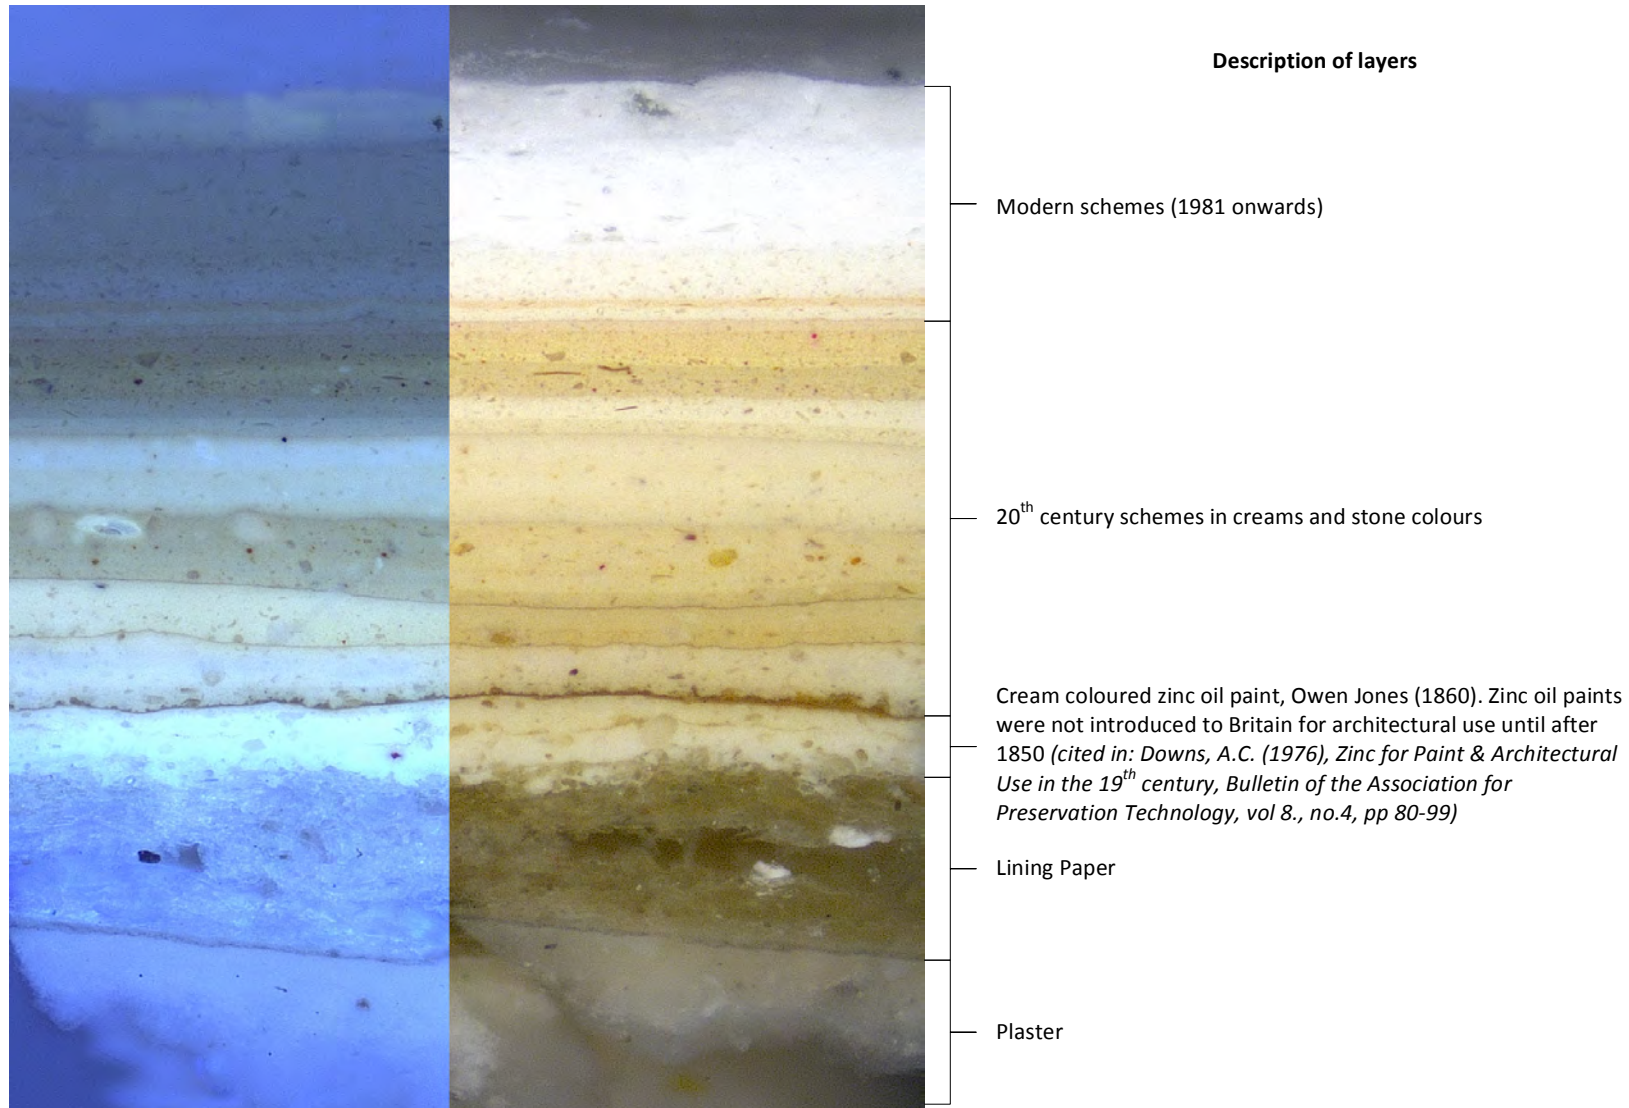
**Fig.6: Sample 2.11 (Ceiling)**

A sample of early ceiling plaster was provided, removed from a section that had previously been removed and stored in the basement. A photomicrograph of this is provided (fig.6), displaying a lining paper above the plaster substrate with a sequence of cream coloured oil paints above. The earliest paint applied immediately above the paper is a cream coloured zinc oil paint (note the bright white fluorescence in fig.6<sup>12</sup>) suggesting a mid C19 date (possibly the Owen Jones period). This evidence adds weight to the fact the ceiling experienced considerable upheaval when the ventilation system was installed in the mid C19 and potentially covered with a lining paper at that time. Further evidence indicates the ceiling was painted to match the upper cornice, up to and including the most recent white decorative schemes.

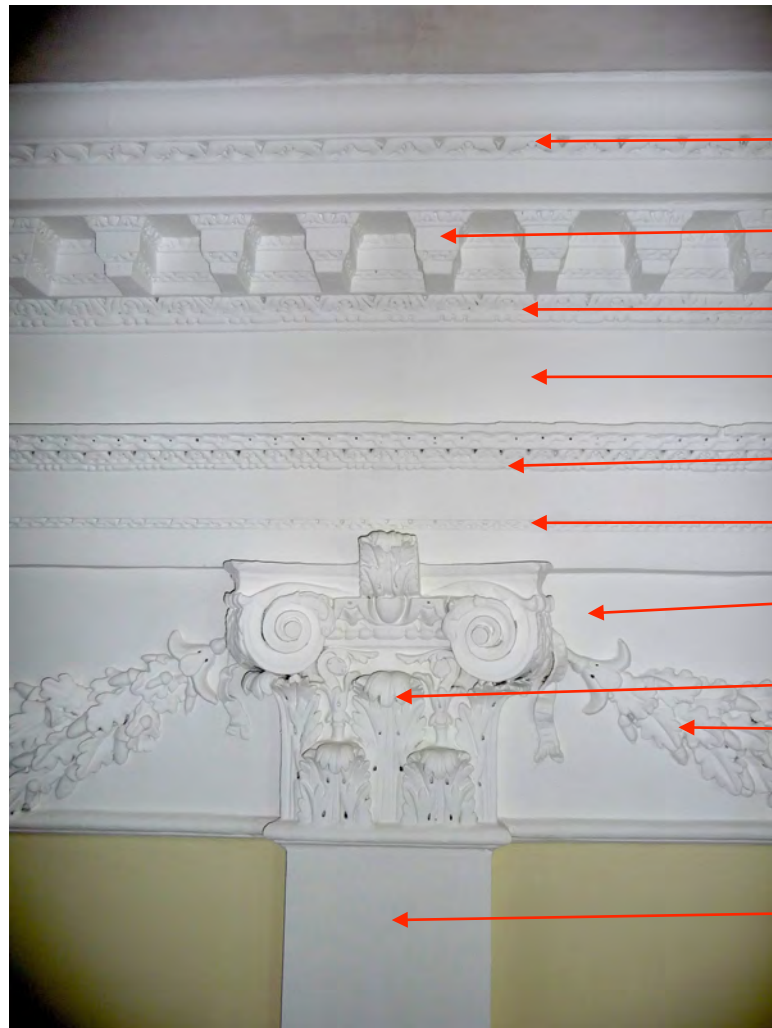
**Fig.7: Sample locations upper level (above clerestory windows)**

*Ceiling sample taken from a section of original material, previously removed and stored on site (sample 2.11)*

Upper waterleaf above modillions (sample 2.10)

Modillions (sample 1.3)

Waterleaf beneath modillions (sample 1.4)

Frieze beneath modillions (sample 1.2)

Bead & reel (sample 1.1)

Lower water leaf (sample 1.5)

Frieze (sample 2.6)

Pilaster capital acanthus (sample 2.8)

Frieze swag (sample 2.7)

Pilaster shaft (sample 2.9)

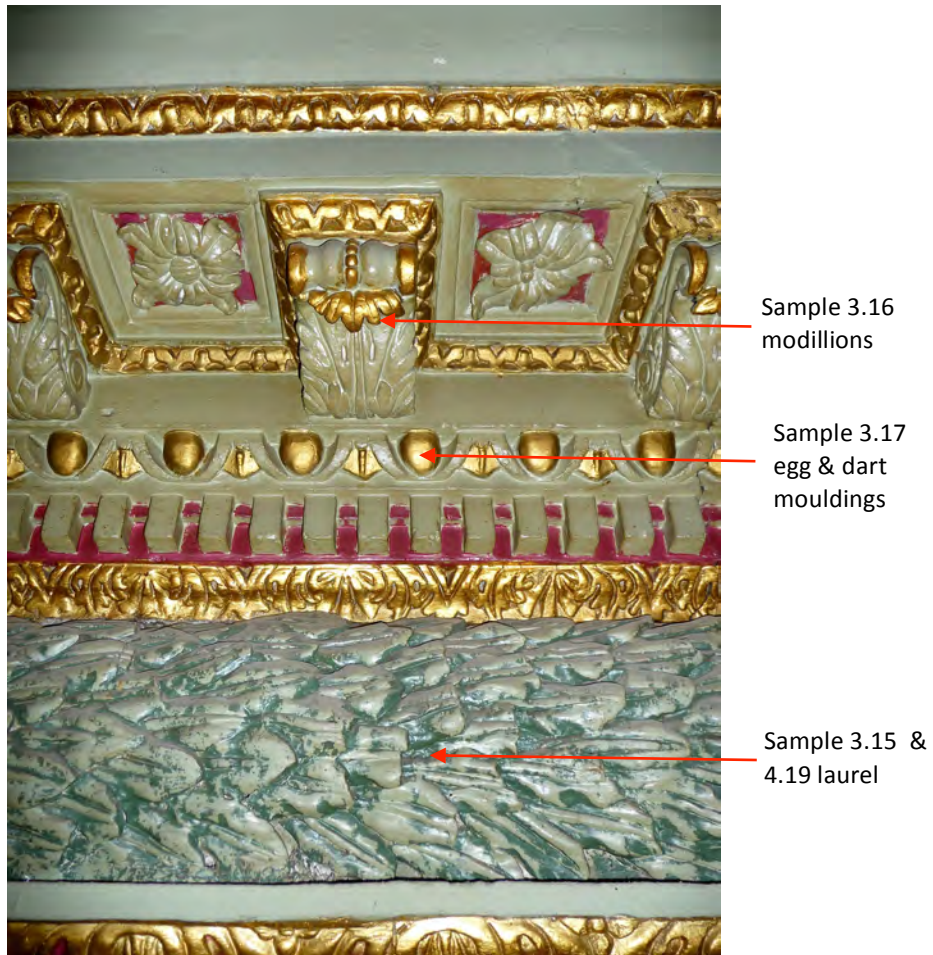
**Fig.8: The entablature (sample locations)**

A number of samples were removed from the entablature and column capitals immediately beneath clerestory level. There is no evidence for 18<sup>th</sup> century decorative schemes on any of the samples removed, with the possible exception of the modillions (sample 3.16). All the remaining samples suggest a mid 19<sup>th</sup> century date, probably just prior to the 1860 Owen Jones scheme.

- The area of frieze sampled (4.18) displayed modern paints only and appears to be a relatively recent replacement (possibly 1950/51)

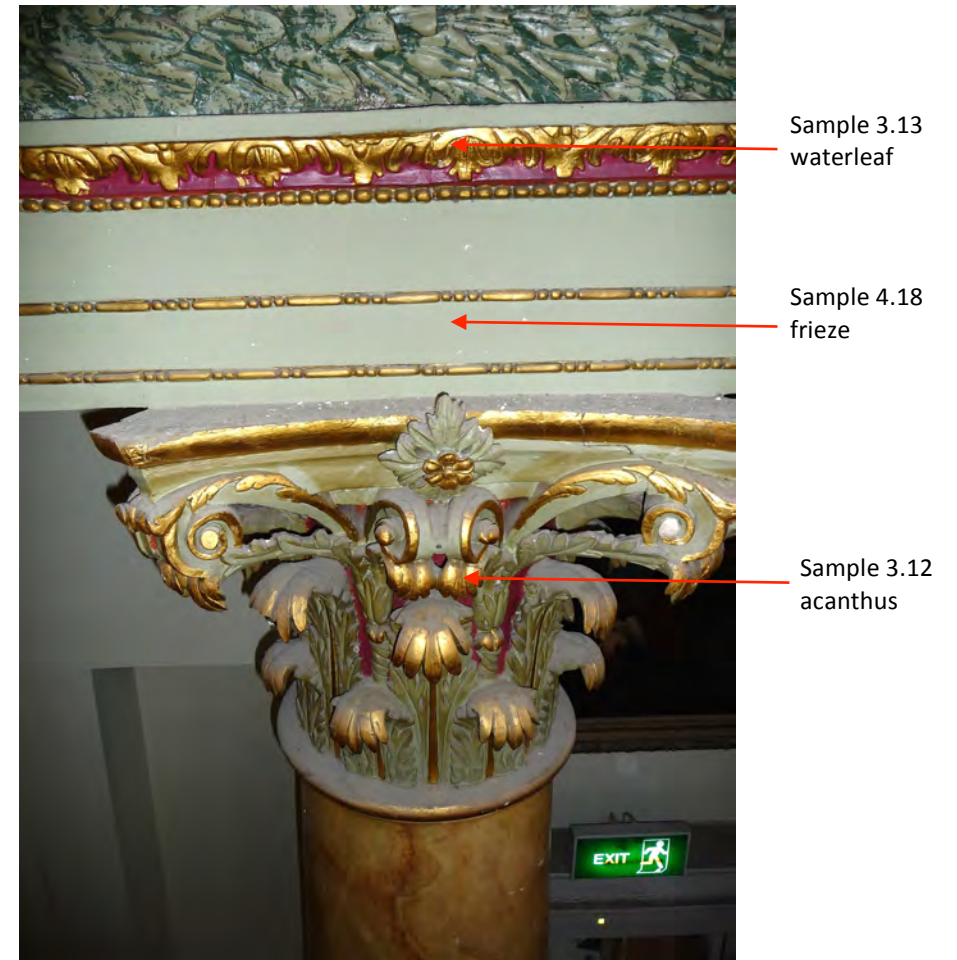
**Fig.9: Column Capital (sample locations)**

- The first gilding applied to the column capitals appears to have taken place during the 1860 Owen Jones scheme. Immediately prior to this they were presented in stone or pale cream
- Both samples removed from the laurel torus (3.15 & 4.19) display a long tradition of the torus being gilded and not painted green
- Egg and dart mouldings (3.17) oil gilded from the mid 19<sup>th</sup> century onwards. Currently painted in gold oil paint.
- The modillions (3.16) – could be the original plaster stucco with traces of pigmented surface. This surface was cleaned and washed prior to the introduction of the 19<sup>th</sup> century schemes.

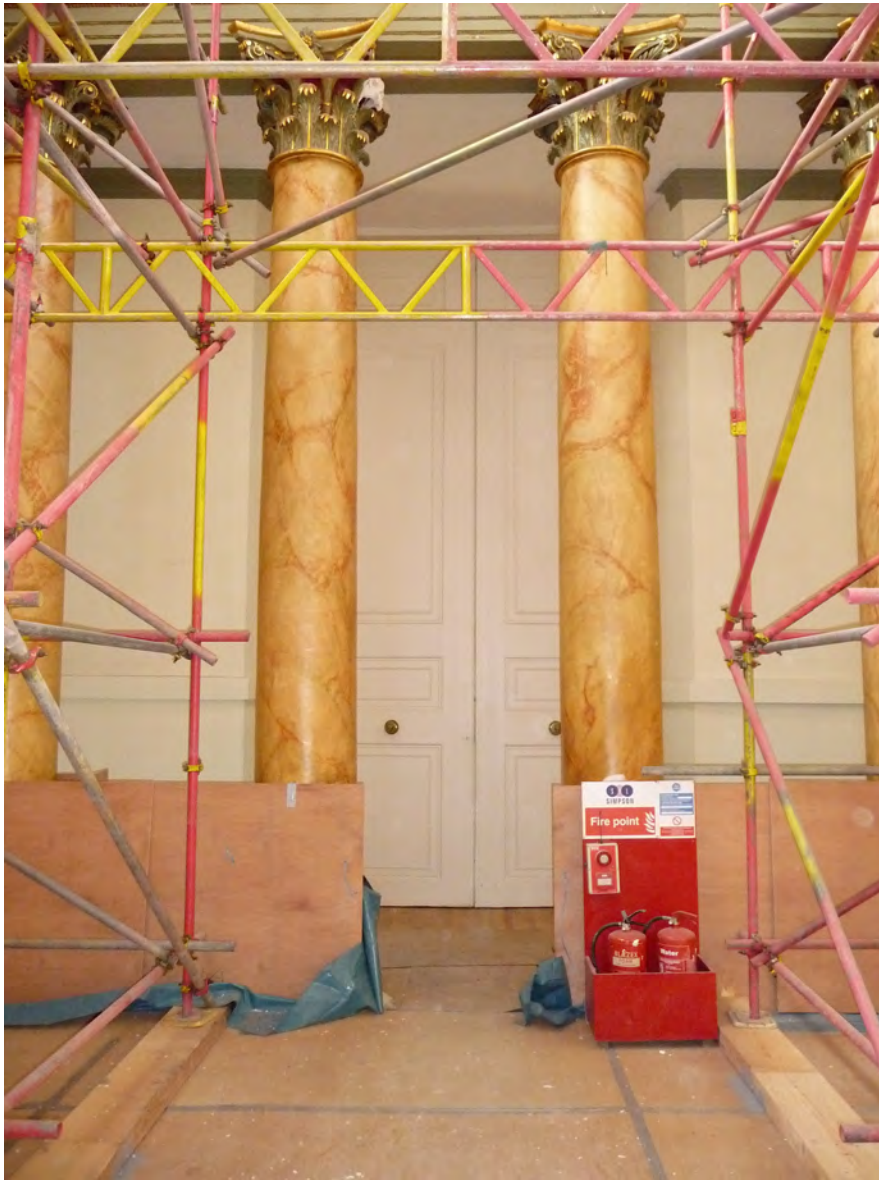
### 5.3: Fig.12, The Column shafts and bases

The columns are currently marbled in a painted faux sienna marbled finish and coated with a polyurethane varnish. This raises the question: *is this a uniquely modern interpretation, or were the column shafts marbled in the past?*

This is impossible to establish from paint sampling alone, which by its very nature only examines a small area (typically 5mm square) and can easily miss the figuring of a marbled finish. To conclusively establish the presence of earlier marbling, the paint layers will need to be removed carefully one layer at a time covering sufficient surface area to reveal the nature of the underlying marbled schemes.

However, there is clear evidence the columns were marbled in the past, starting with an etching in the London Illustrated News (1864) and further photographs dating to c1940 and c1950 included in the Maybank Conservation Management Plan (pp. 31/32). This is further endorsed by another photograph of the interior taken during the 1928 Radio Exhibition and included later in this report, along with additional observations.

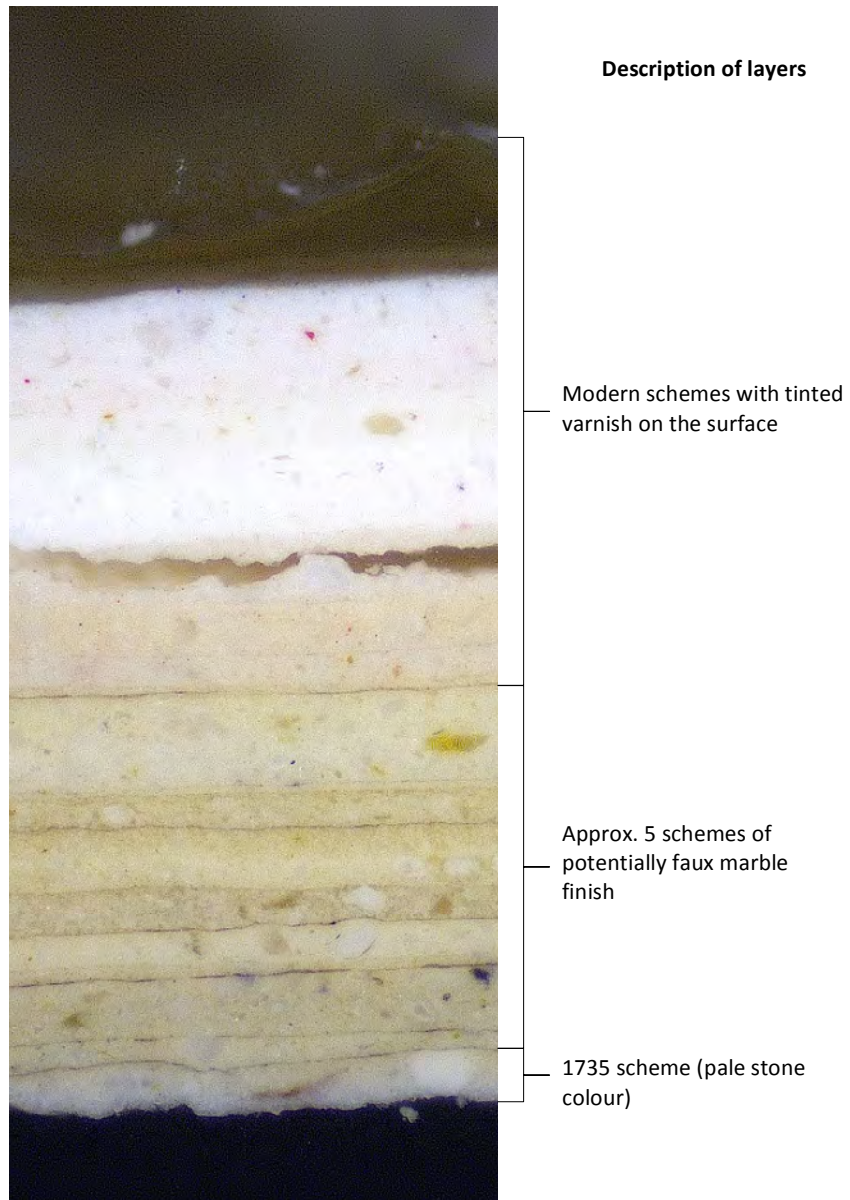
**Fig.13: Sample 4.21 Column shafts**

Although the cross section removed from the column shaft was inconclusive it is included here for the academic record.

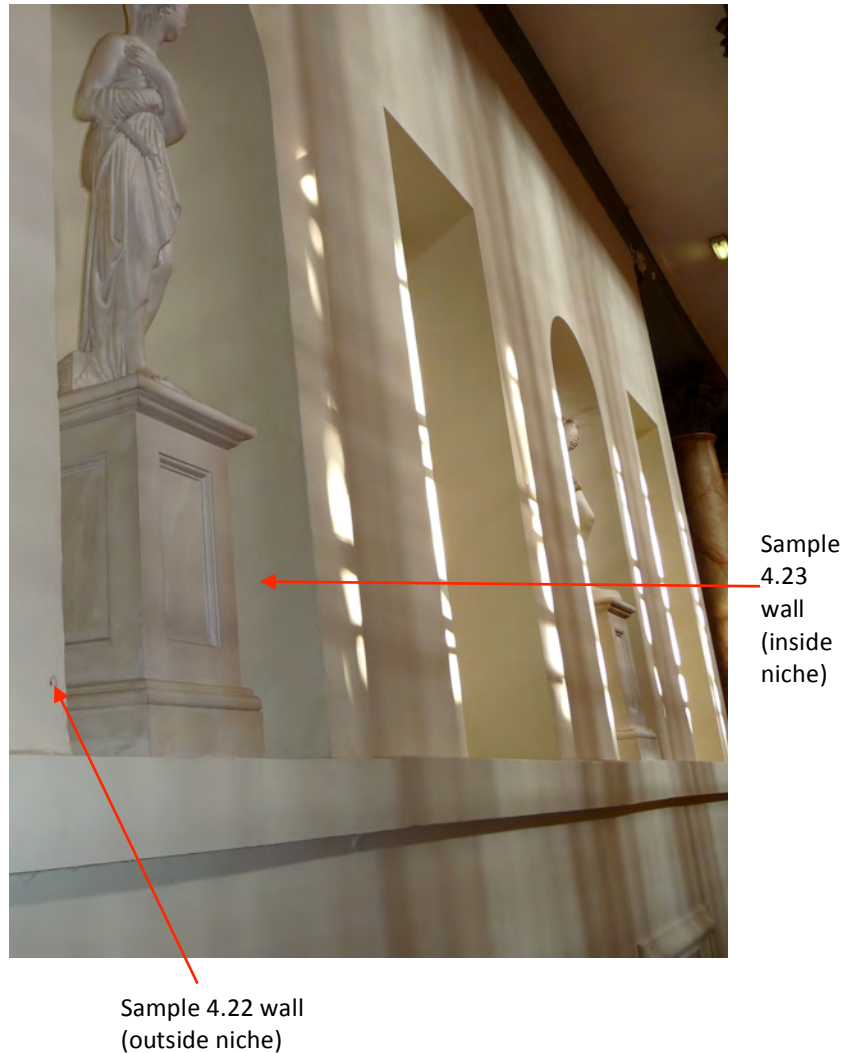
#### 5.4: Fig.15, The Walls (sample locations)

The internal wall faces were closely examined to find an area that demonstrated a heavy build up of paint and potentially a full chronology of decorative schemes dating back to the early 18<sup>th</sup> century.

Two samples were removed from the north wall (as indicated left), one inside the niche and the other from the edge of the wall immediately outside. Photomicrographs of both are shown overleaf with a layer of soft distemper at the base (earliest decorative scheme) on each.

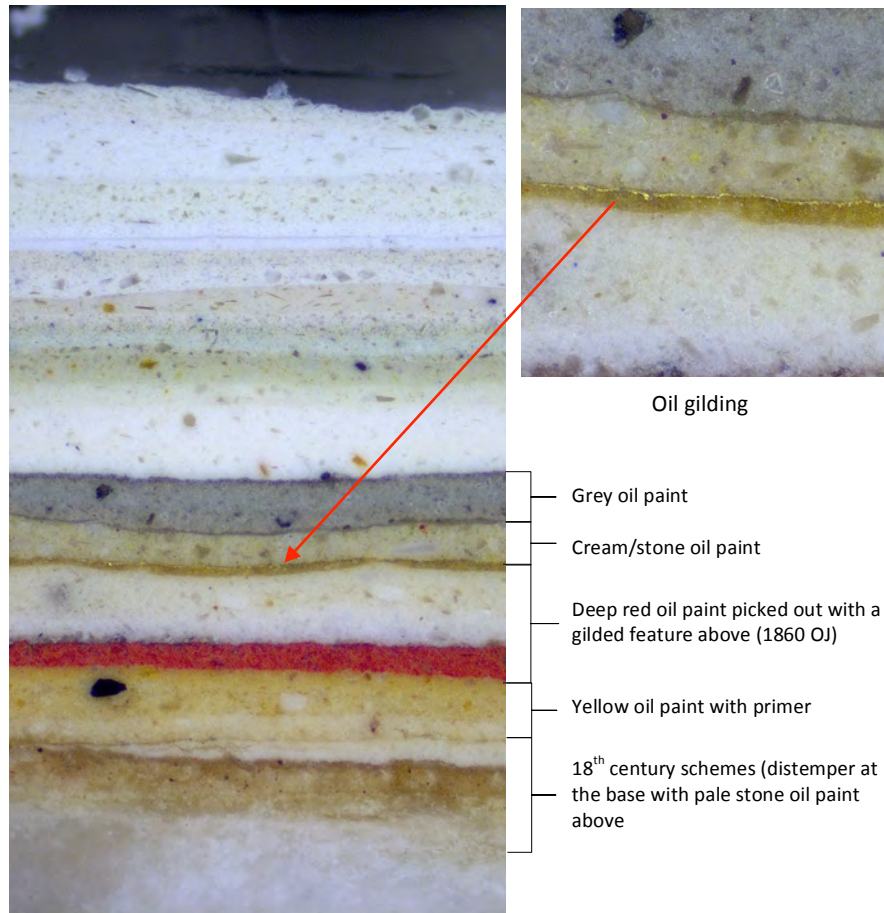
**Fig.16: Sample 4.22 wall (outside niche)**

Immediately after construction the walls and niches were decorated uniformly in stone coloured distemper. More than one application may have been applied and left in place until the first oil paints were applied in pale stone. Although unclear precisely when this occurred it may have been Staveley's scheme in 1755. A yellow oil paint was applied to both walls and niches in the early 19<sup>th</sup> century.

The Owen Jones scheme of 1860 sees the first time the niches were picked out in a different colour to the surrounding walls, with red walls and darker red/brown niches, presumably to enhance the statuary housed within them. There is also clear evidence for some localised gilding to the edge of the niche wall at this time with the precise nature of this, without further research unclear at this time. Another stone coloured scheme was further applied prior to a theme of grey walls with pale grey niches. All subsequent modern schemes were applied uniformly in pale greens and cream.

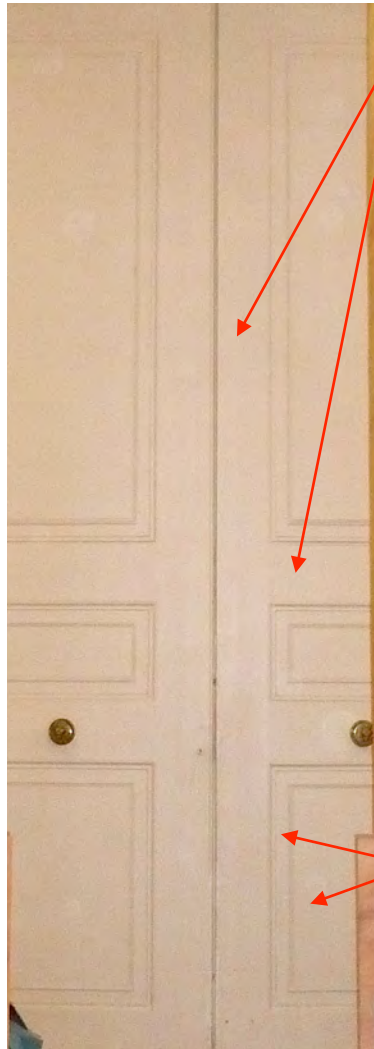
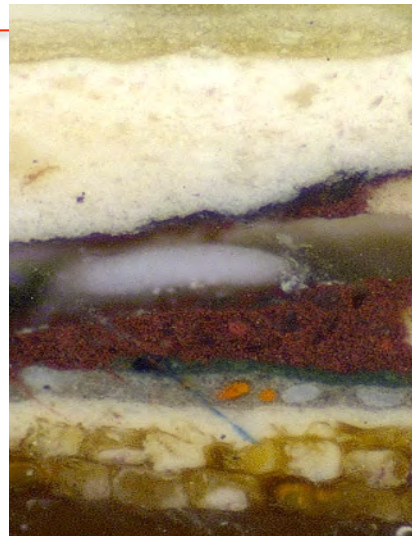
## 5.5: Figs.18 & 19 Main door

Immediately after installation in the early 18<sup>th</sup> century the entire door was primed in white lead (at the base of the image) with a coarse grey undercoat immediately above.

A green top coat was applied on top of the grey undercoat

The muntins and stiles were then over painted in chocolate brown oil paint

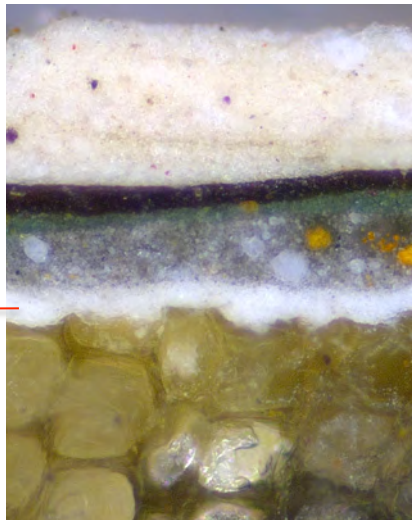
The door panels themselves remained green with the bolection mouldings picked out in black oil paint

Only the earliest decorative scheme is depicted here. The two photomicrographs (left) clearly show the cell structure of the timber substrate at the base with a white lead primer immediately above.

Subsequently a grey undercoat was applied with a dark green oil immediately above. This created a uniform dark green across the entire surface of the door.

When dry, the muntins and stiles were picked out in chocolate brown and the bolection mouldings in black.

The use of green, brown and black in this manner is a typical Palladian colour scheme.

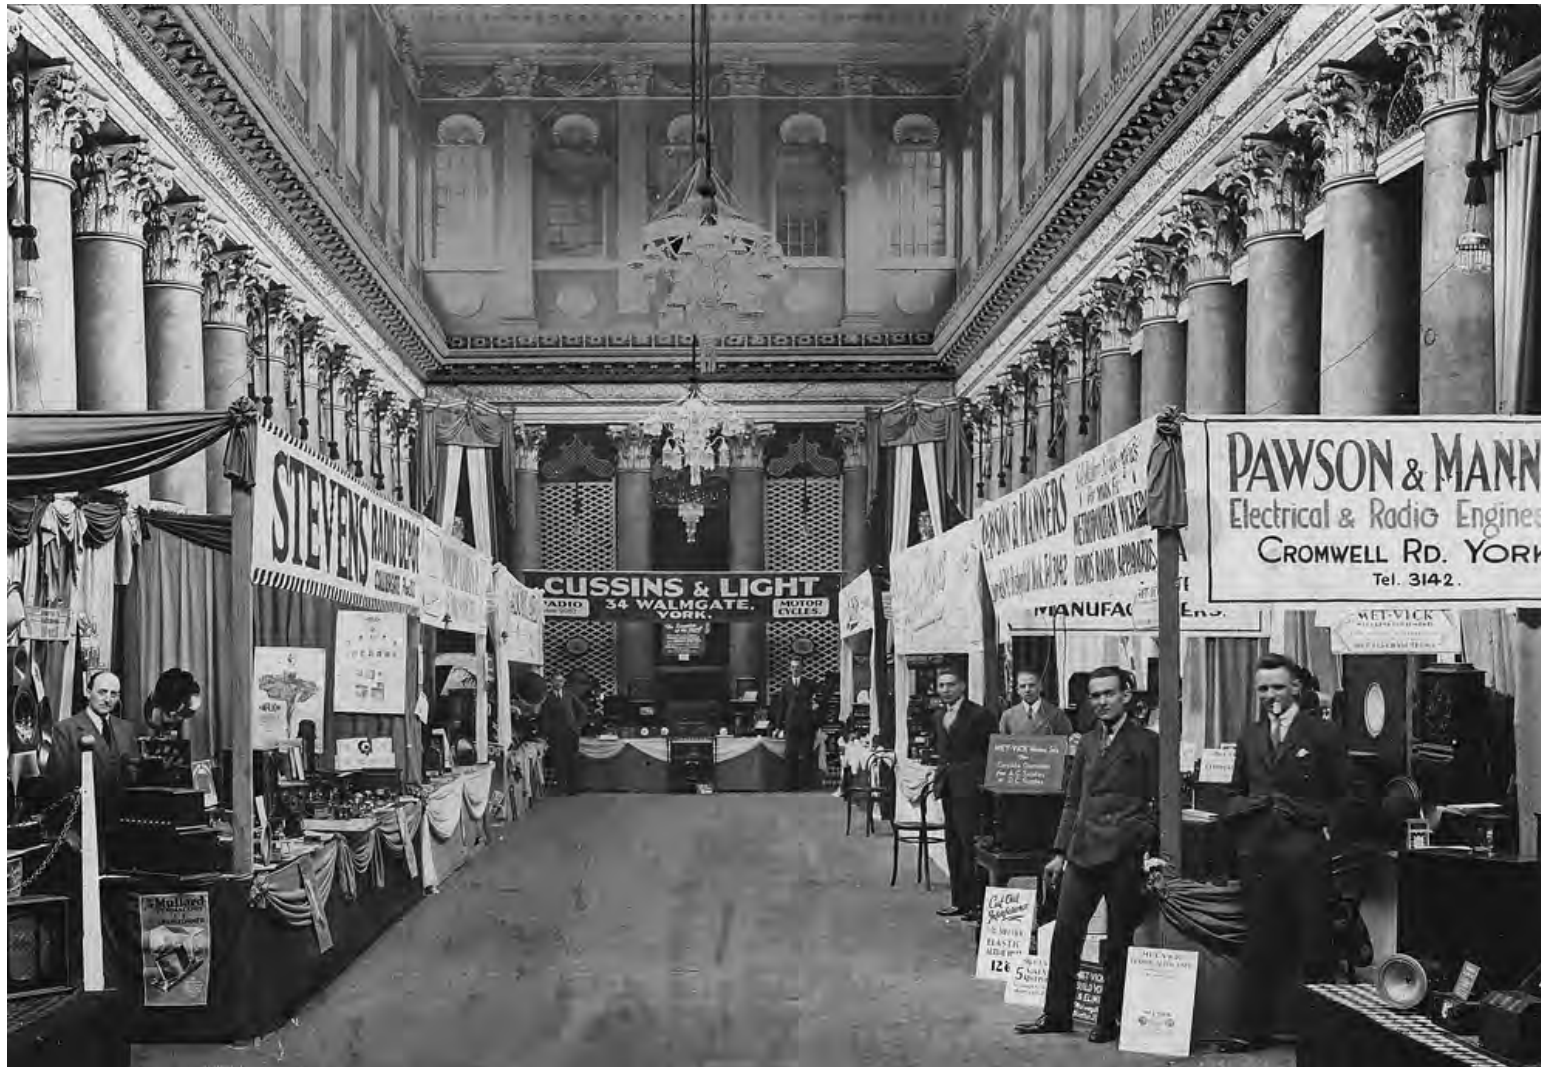
**Fig.20: 1928 Radio Exhibition**

Note the scallop shells above the windows and oval plaques beneath. These were introduced by Staveley in 1755 and removed during the 1950/51 restoration.

Faux marbling to the columns
